Evaluation of Damage to a Historic Masonry Building in Nepal through Comparison of Dynamic Characteristics before and after the 2015 Gorkha Earthquake

Aiko Furukawa^{1*}, Junji Kiyono¹, Rishi Ram Parajuli¹, Hari Ram Parajuli² and Kenzo Toki³

On April 25, 2015, a M_w 7.8 earthquake struck the Gorkha district of Kathmandu, Nepal. In Patan, vibrational characteristics of a 300-year-old two-story masonry building near Patan Durbar Square had been measured prior the Gorkha earthquake. In the inspection of the building after the Gorkha earthquake, several new cracks were found. The vibrational characteristics of the building were measured again, and it was found that the natural frequencies after the earthquake were smaller than those before the earthquake, indicating the reduction of the stiffness. Finite element models of the structure representing pre- and post-earthquake conditions are established so that the natural frequencies match the pre- and post-earthquake measurements and the structural damage is identified based on the stiffness reduction. Finally, the dynamic analysis of the finite element model of the building in the pre-earthquake condition using the observed ground mot

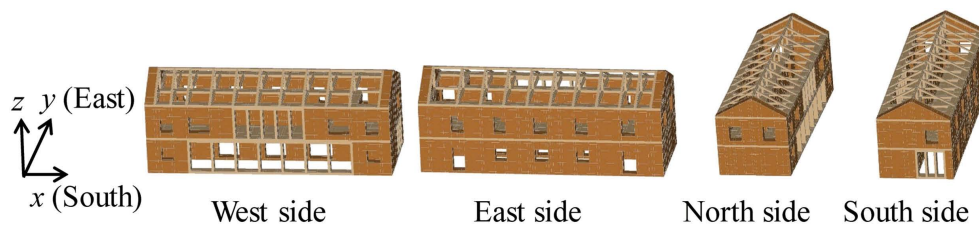
FIGURE 7 | Finite element model of the target building.

In the finite element modeling of the building shown in **Figure 7**, the following assumptions are introduced. The thickness of

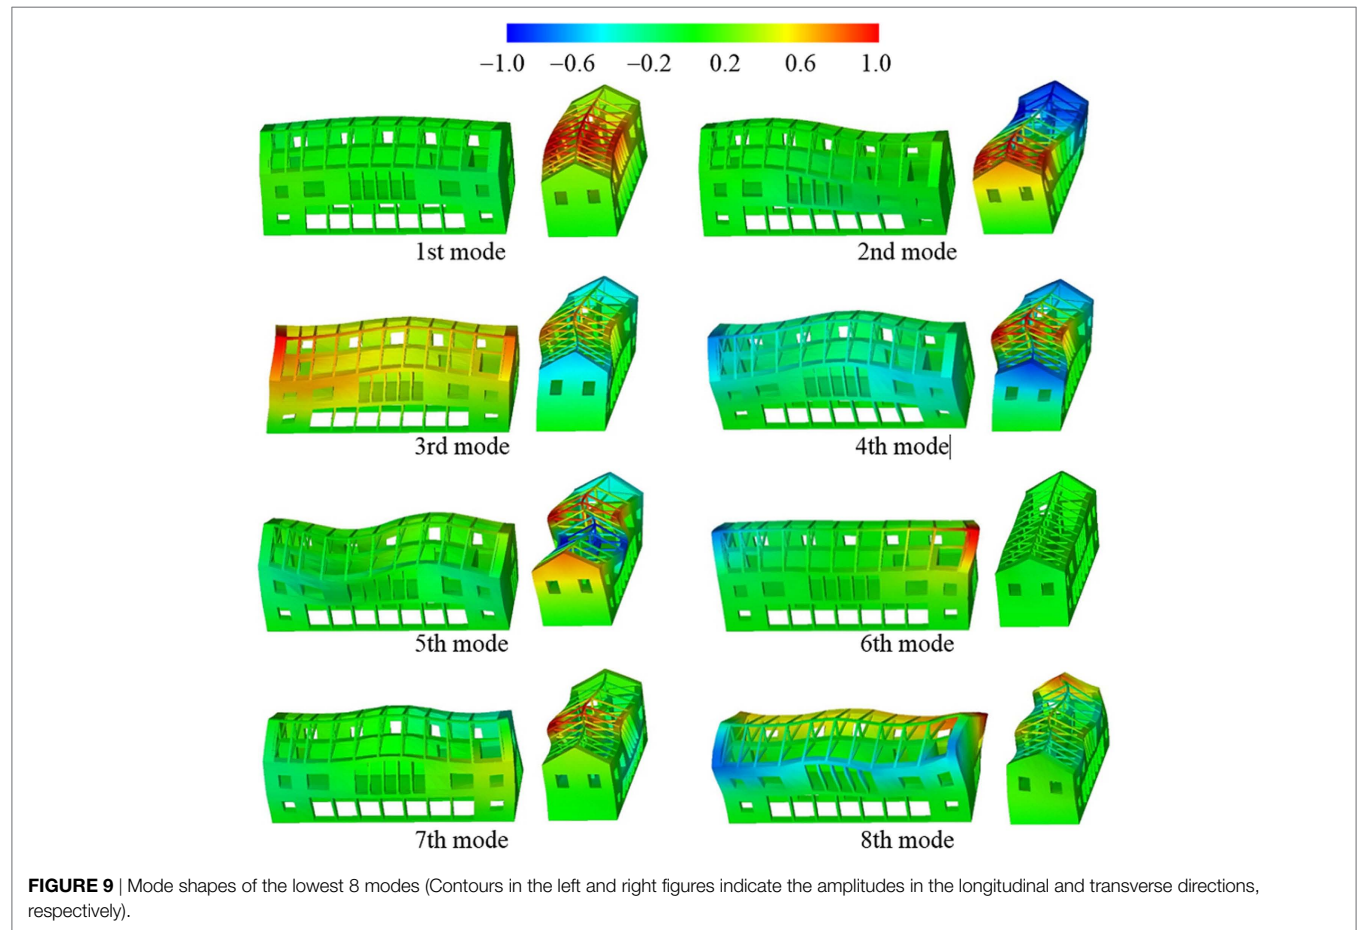
FIGURE 9 | Mode shapes of the lowest 8 modes (Contours in the left and right figures indicate the amplitudes in the longitudinal and transverse directions, respectively).

The mode shapes of the eight natural modes are shown in Figure 9. The eigenvector is scaled so that the largest absolute value of its elements be 1.0. Those mode shapes conform to the observed Fourier amplitude spectra shown in Figure 6. For example, the third, sixth, and eighth modes are dominant in the longitudinal (x) direction and other modes are dominant in the transverse (y) direction. In the second mode shown in Figure 9, the phases of the north and south side vibrations are opposite as observed in Figure 6C.
